Contract #: 04-0120F4Cty: SF/ALA Rte: 80 PM: 13.2/13.9File #: 1.28**WELDING INSPECTION REPORT****Resident Engineer:** Casey, William**Address:** 333 Burma Road**City:** Oakland, CA 94607**Report No:** WIR-028469**Date Inspected:** 22-Sep-2012**Project Name:** SAS Superstructure**OSM Arrival Time:** 700**Prime Contractor:** American Bridge/Fluor Enterprises, a JV**OSM Departure Time:** 1500**Contractor:** American Bridge/Fluor Enterprises, a JV**Location:** jobsite**CWI Name:** Chris Concha**CWI Present:** Yes No**Inspected CWI report:** Yes No N/A**Rod Oven in Use:** Yes No N/A**Electrode to specification:** Yes No N/A**Weld Procedures Followed:** Yes No N/A**Qualified Welders:** Yes No N/A**Verified Joint Fit-up:** Yes No N/A**Approved Drawings:** Yes No N/A**Approved WPS:** Yes No N/A**Delayed / Cancelled:** Yes No N/A**Bridge No:** 34-0006**Component:** OBG**Summary of Items Observed:**

WELDING INSPECTION REPORT

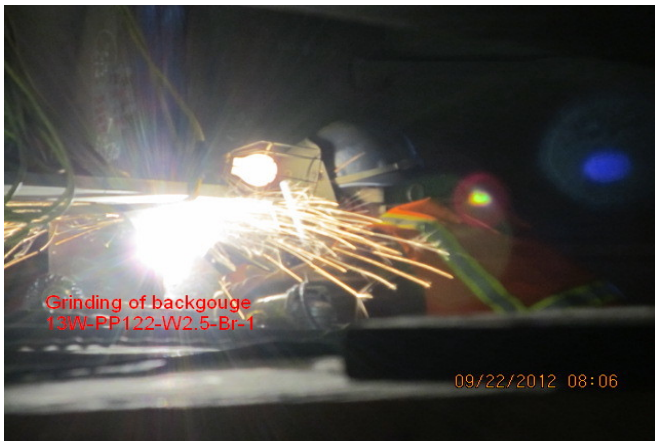
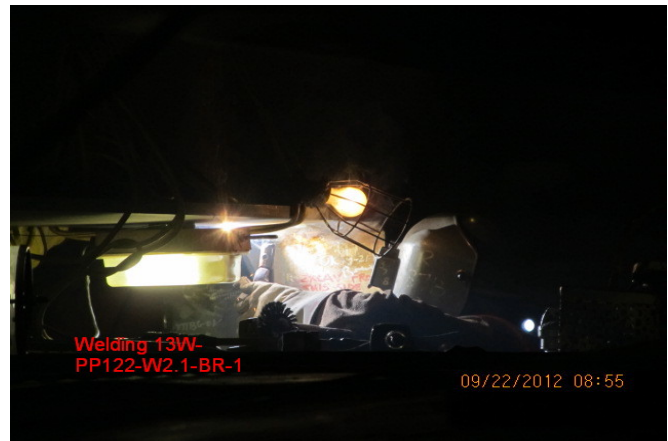
This QAI observed the fitting of gusset plate BR-1 to column and floor beam 13W-PP122.5-W2.1 by ABF Welder Richard Garcia. Prior to fitting of the gusset plate the welder removed the prime paint in the areas weld would be deposited by grinding. At the conclusion of grinding the gusset plate was fit square to the column and bottom flange of the floor beam and tacked into place using the Shield Metal Arc welding with E7018 H4R electrode.

The welder spent all of the shift depositing the root passes and fill passes with approximately 100% being completed at the end of the shift. QC inspector Concha was noted to be present in order to monitor the progress and ensure the welding was within the established Welding Procedure Specification (WPS) noted as ABF-WPS-D15-1008 Rev 0 and supporting Procedure Qualification Records (PQR). Prior to and during the welding at this location the QC inspector observed the preheat temperature using a Raytek non-contact Thermometer, was sufficient and compliant to the above-mentioned WPS. Using a Tempil Stick, (temperature indicating crayon) the pre-heat was then verified by this QA inspector to be greater than 150F. Using a Fluke brand Tong style meter, the parameters were verified to be 124.
